# CASE STUDY

## Metals & Mining

**Location:** Saskatchewan, Canada

**Application:** Potash Belt Galleries

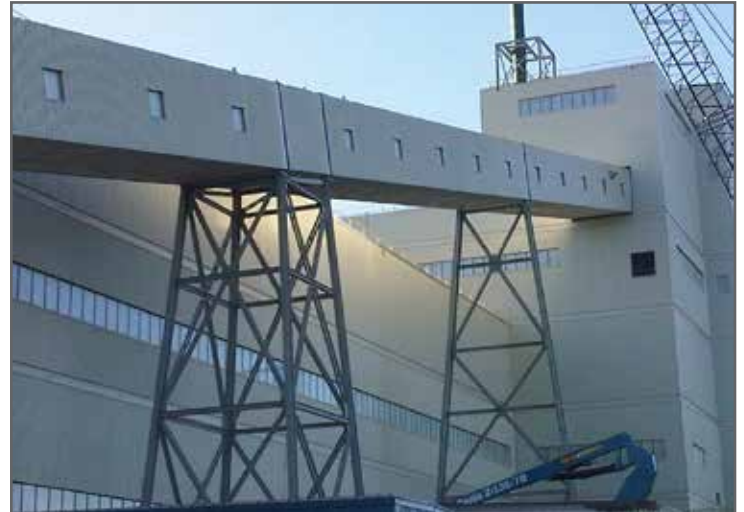
It was determined that the floor system in the new galleries needed to be both corrosion resistant and waterproof, so that no potash or water could end up in contact with the steel structure and affect the structural integrity of the gallery. StonCor's Fibergrate and Carboline Divisions stepped up with an innovative design to solve this issue.

Fibergrate designed, fabricated and installed a seamless floor and wall structure using a combination of existing and newly engineered FRP components. Components were fabricated in Fibergrate's 37,000 square foot fabrication facility in Oshawa, Ontario. Once completed, these components were shipped to B.I.D Ltd. in Woodstock, New Brunswick, where they were installed on the steel belt gallery frames and prepared for final assembly on site.
